Integrated Functional Appraisal (IFA) Nuclear Science Division

June 30, 2005

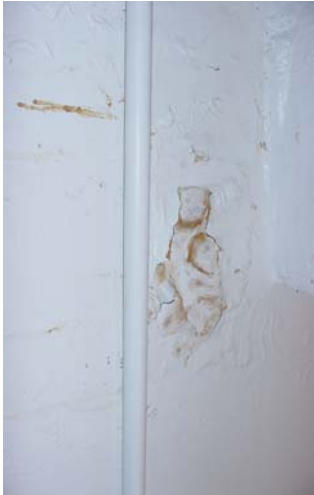
Fig. 1. Building 88, Cave1: Damaged/peeling lead based paint on the wall at the cave entrance at the seismic joint.

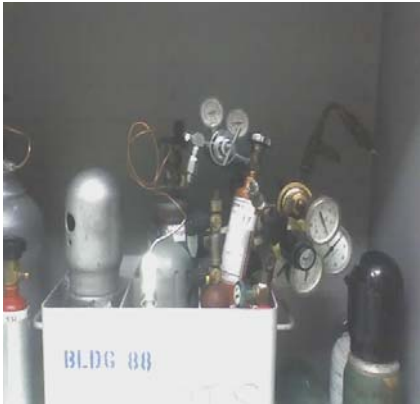
Fig. 3. Building 88, Cave Roof: Inappropriate storage of gas lecture bottles. Some bottles have regulators attached and others have caps.
